SUMMARY OF FIELD DENSITY TEST RESULTS
EMBANKMENT FILL

ACCESS ROAD
KAHUKU LANDS DEVELOPMENT
KAHUKU, OAHU, HAWAII

INSCON DEVELOPMENT COMPANY

Dames & Moore Job No. 7577-011

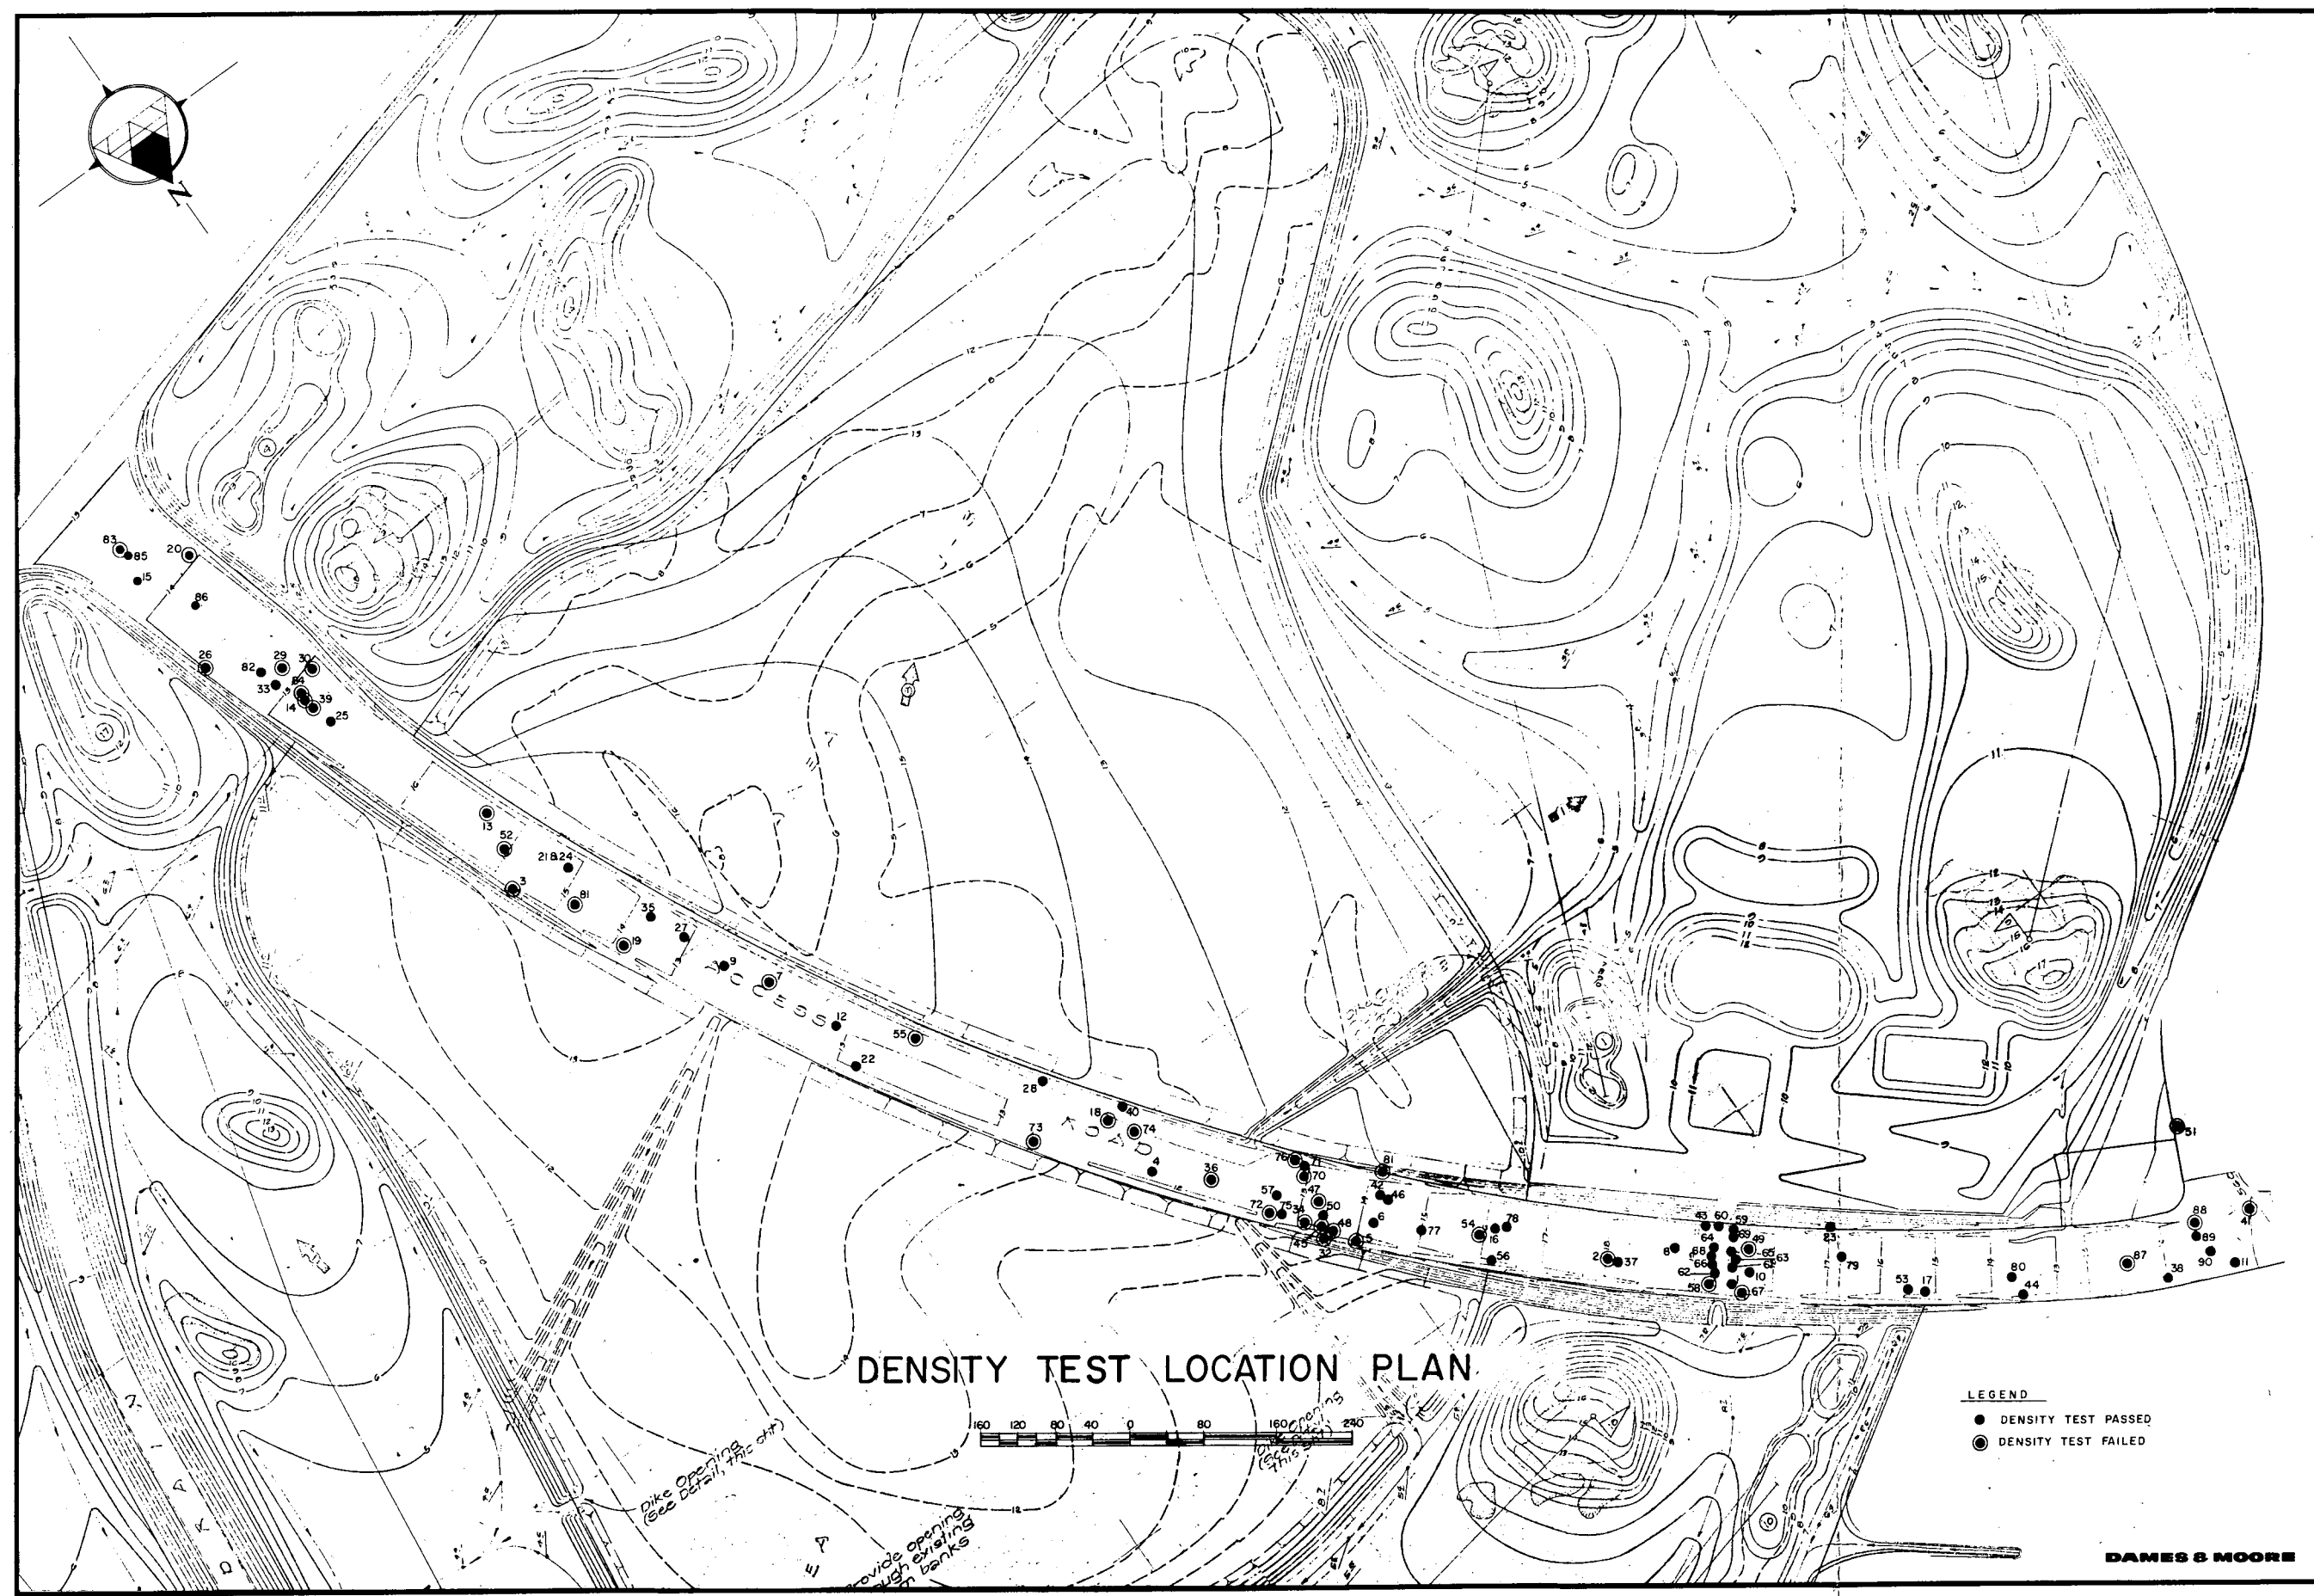
This letter summarizes the results of field density tests performed during construction of embankment fills for the Access Road at your Kahuku Lands Development project. The location at which each density was performed is presented on the Location of Field Density Test Plan, Attachment 1. The Summary of Density Tests is presented on Attachment 2.
